<p><b>Project Number and Name: 2-1 Road Erosion along Lower Bald Top Rd (near Intersection with Lake Morey Road)</b></p>	
<p>Land Ownership: Town of Fairlee</p>	
<p>Site Location: Bald Top Road – Lower end of Bald Top Road above intersection with Lake Morey Road</p>

# Lake Morey Watershed Action Plan

## Road Problem Areas Summary Sheet

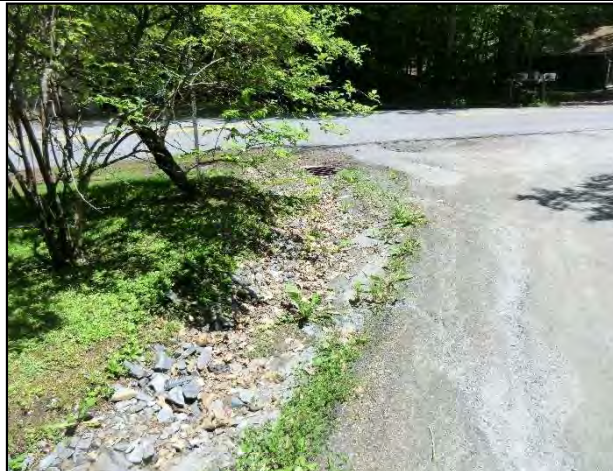
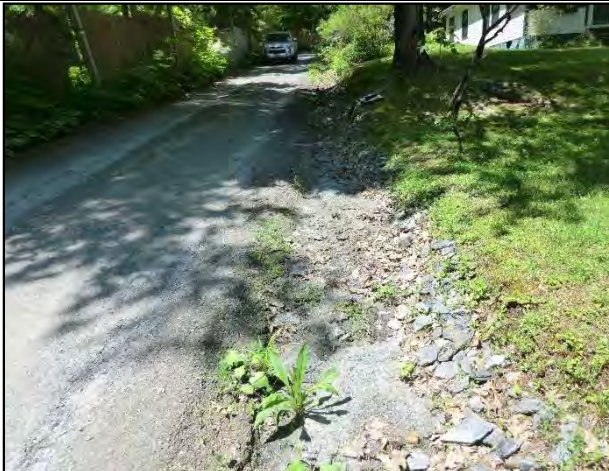
<p>Site Description: Roadside ditches are steep. The rock lined ditch leads to a drop inlet at intersection of Bald Top Road and Lake Morey Road.</p>

<p>Site Design Considerations: The roadway is steep. Raise the road and grade toward the rock lined ditch. Grading of the road will help reduce sediment input by reducing riling.</p>	
<p>Permitting Needs: No permits are required for this project.</p>	
<p>Cost Estimate Range: \$40,000 to \$50,000</p>	
<p>Restoration/Water Quality Improvement Objectives: Reduce sediment and phosphorus reaching Lake Morey by reducing road erosion.</p>	
<p>Level of Landowner Commitment: Unknown</p>
