<p><b>Project Number and Name: 2-1 Road Erosion along Lower Bald Top Rd (near Intersection with Lake Morey Road)</b></p>	
<p>Land Ownership: Town of Fairlee</p>	
<p>Site Location: Bald Top Road – Lower end of Bald Top Road above intersection with Lake Morey Road</p>

# Lake Morey Watershed Action Plan

## Road Problem Areas Summary Sheet

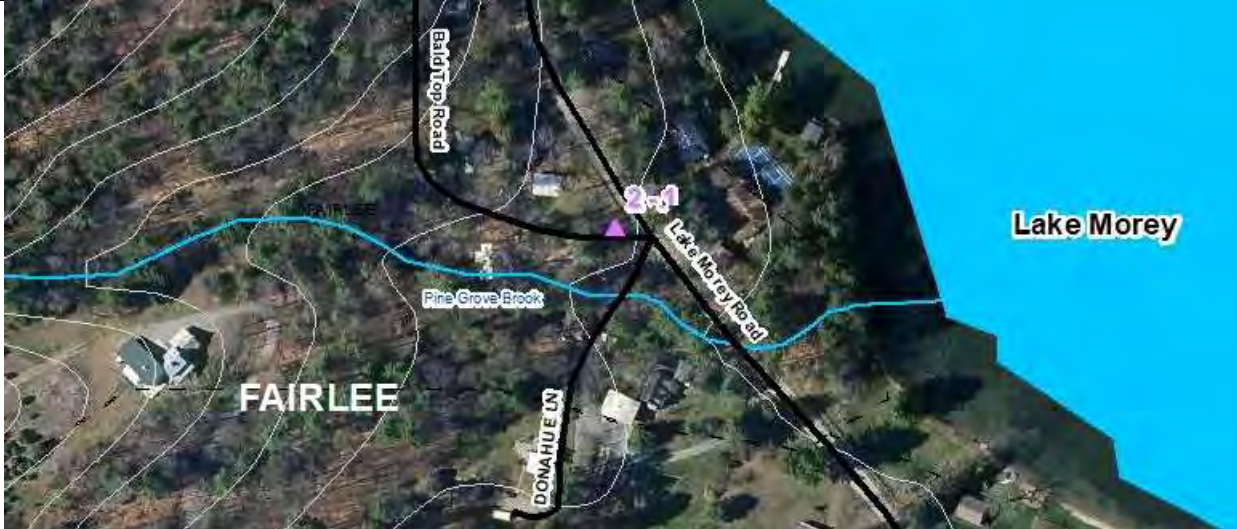
<p>Site Description: Roadside ditches are steep. The rock lined ditch leads to a drop inlet at intersection of Bald Top Road and Lake Morey Road.</p>

<p>Site Design Considerations: The roadway is steep. Raise the road and grade toward the rock lined ditch. Grading of the road will help reduce sediment input by reducing riling.</p>	
<p>Permitting Needs: No permits are required for this project.</p>	
<p>Cost Estimate Range: \$40,000 to \$50,000</p>	
<p>Restoration/Water Quality Improvement Objectives: Reduce sediment and phosphorus reaching Lake Morey by reducing road erosion.</p>	
<p>Level of Landowner Commitment: Unknown</p>
